# Wake Robin Inn - 104 & 106 Sharon Road, Salisbury, Connecticut

## Soil Scientist Report

### **ARADEV LLC**

July 17, 2024

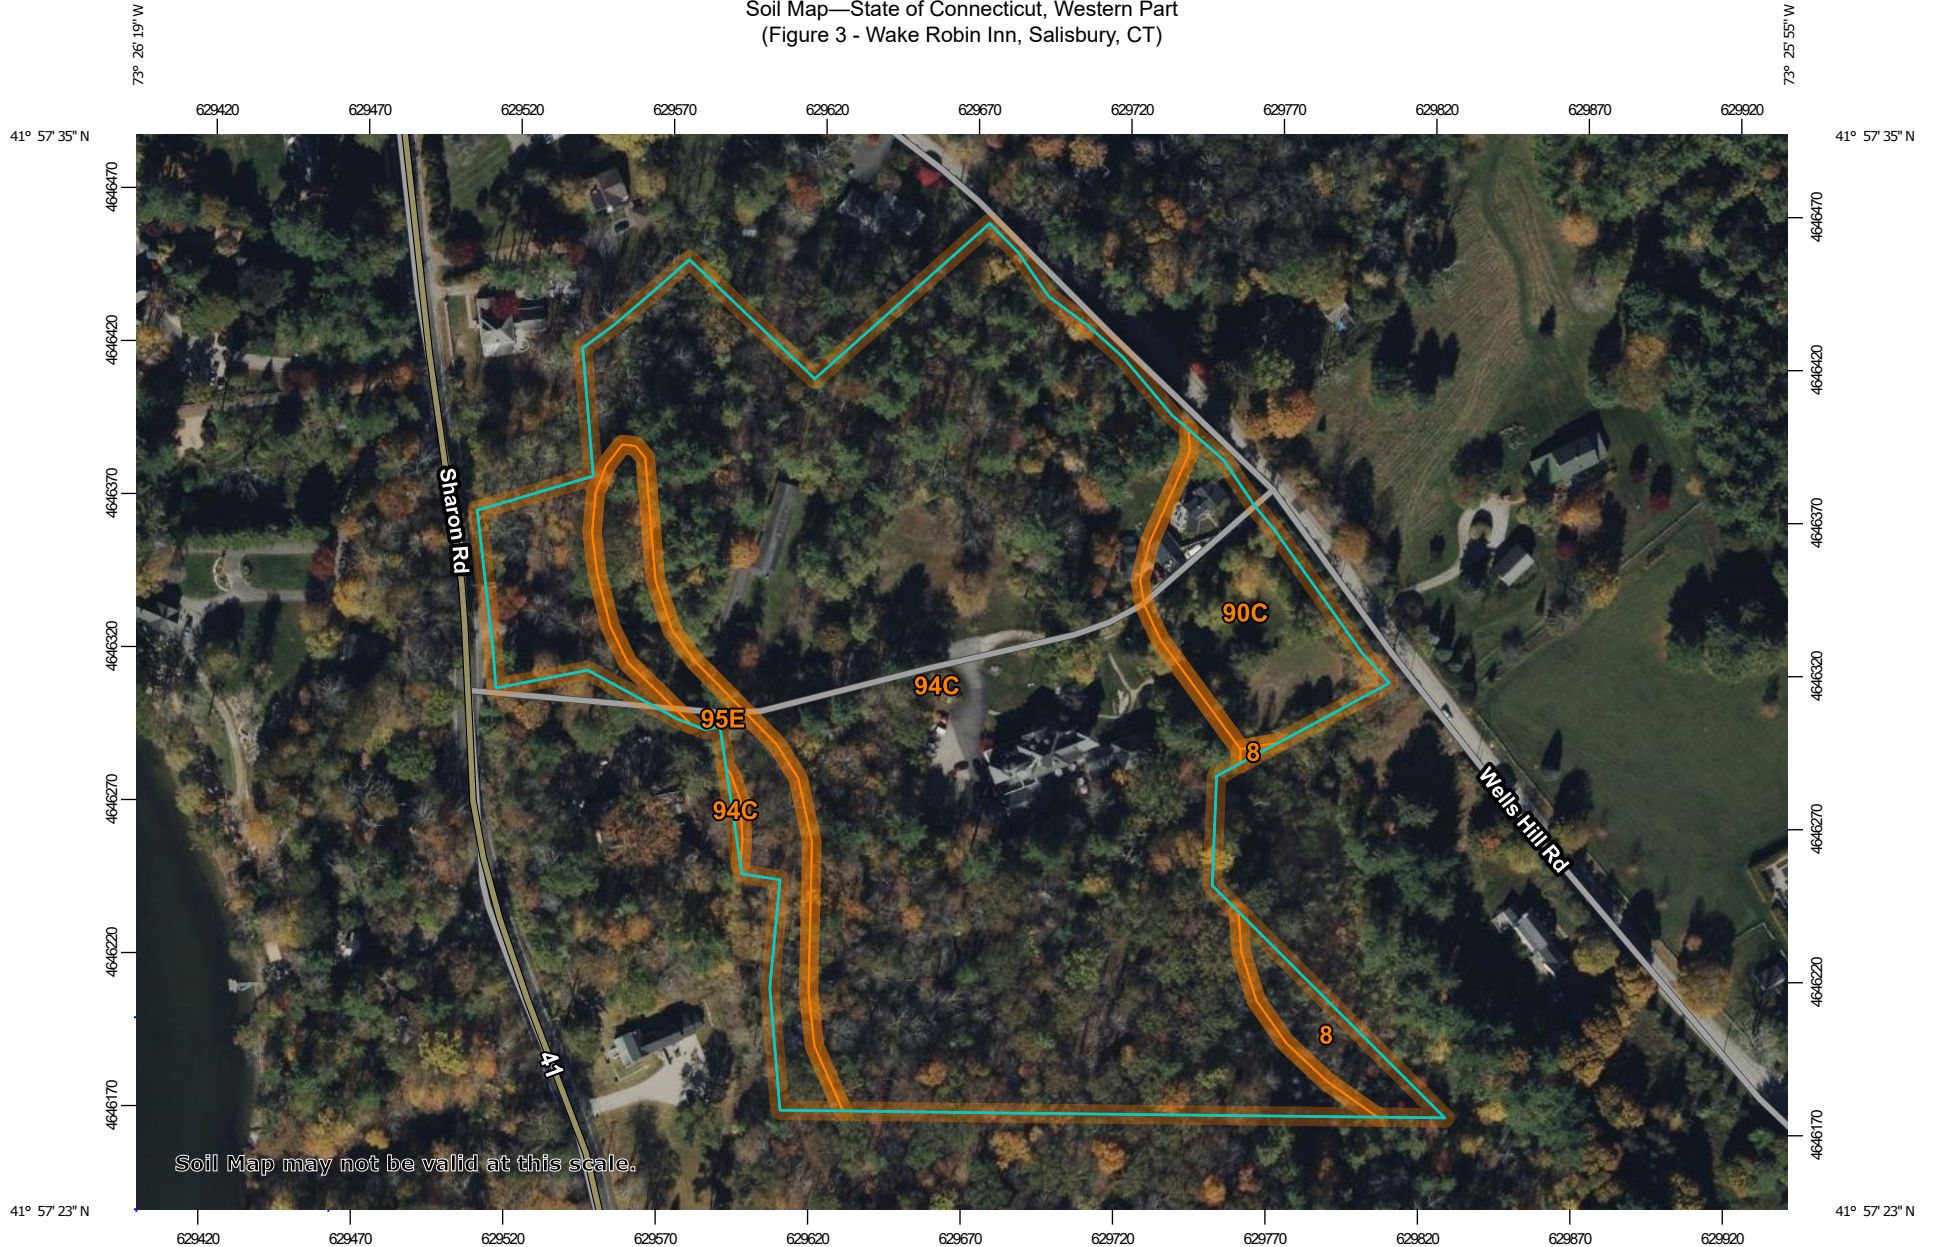
Soil Map—State of Connecticut, Western Part  
(Figure 3 - Wake Robin Inn, Salisbury, CT)

Geospatial data were accessed via the USDA – Natural Resources Conservation Service (USDA-NRCS) web soil survey mapping. The soil survey mapping is appended (**Figure 3**). The survey identifies the following soil mapping units with associated NRCS map number in the subject property, including two wetland soils series/complexes:

- Mudgepond and Alden soils, extremely stony (8) – Poorly drained
- Stockbridge loam, 8 to 15% slopes (90C) – Well drained
- Farmington-Nellis complex, 3 to 15% slopes, very rocky (94C) – Well drained
- Farmington-Rock outcrop complex, 15 to 45% slopes (95E) – Well drained

Map Unit Symbol	Map Unit Name	Acres in AOI	Percent of AOI
8	Mudgepond and Alden soils, extremely stony	0.3	2.5%
90C	Stockbridge loam, 8 to 15 percent slopes	1.1	7.9%
94C	Farmington-Nellis complex, 3 to 15 percent slopes, very rocky	11.0	82.5%
95E	Farmington-Rock outcrop complex, 15 to 45 percent slopes	0.9	7.0%
<b>Totals for Area of Interest</b>		<b>13.3</b>	<b>100.0%</b>

Soils were examined using a Dutch auger. Field investigations generally confirmed the NRCS mapping of poorly drained soils being found along the eastern portion of the site. Please note that SLR did not fully delineate upland soil types onsite.

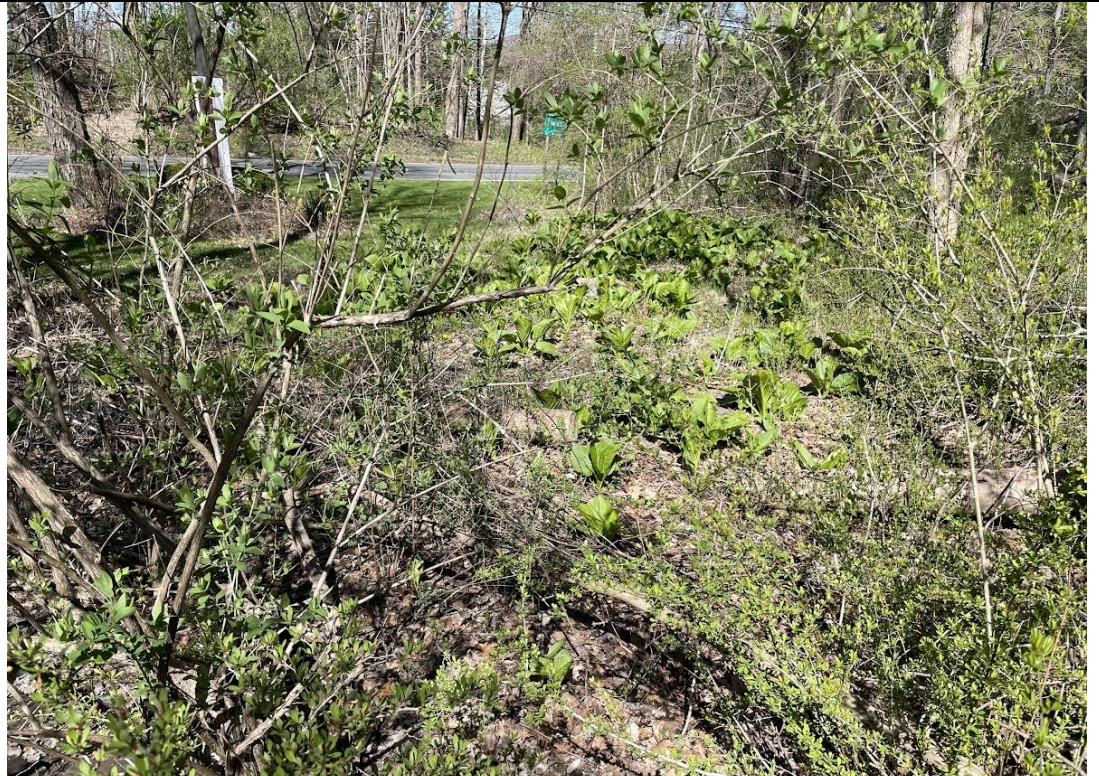
Photo No.  
1

Description:  
Westernmost portion of  
Wetland A, facing Sharon  
Road.

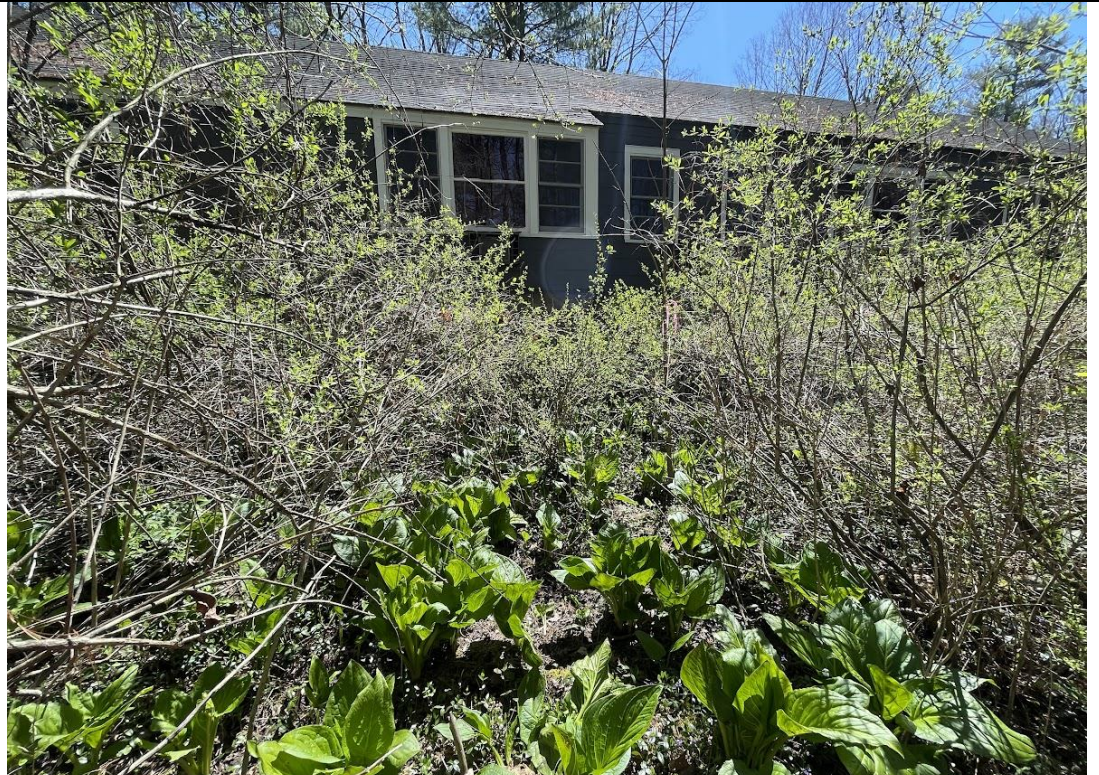
Photo No.  
2

Description:  
Easternmost portion of  
Wetland A behind (west) of  
existing hotel building.

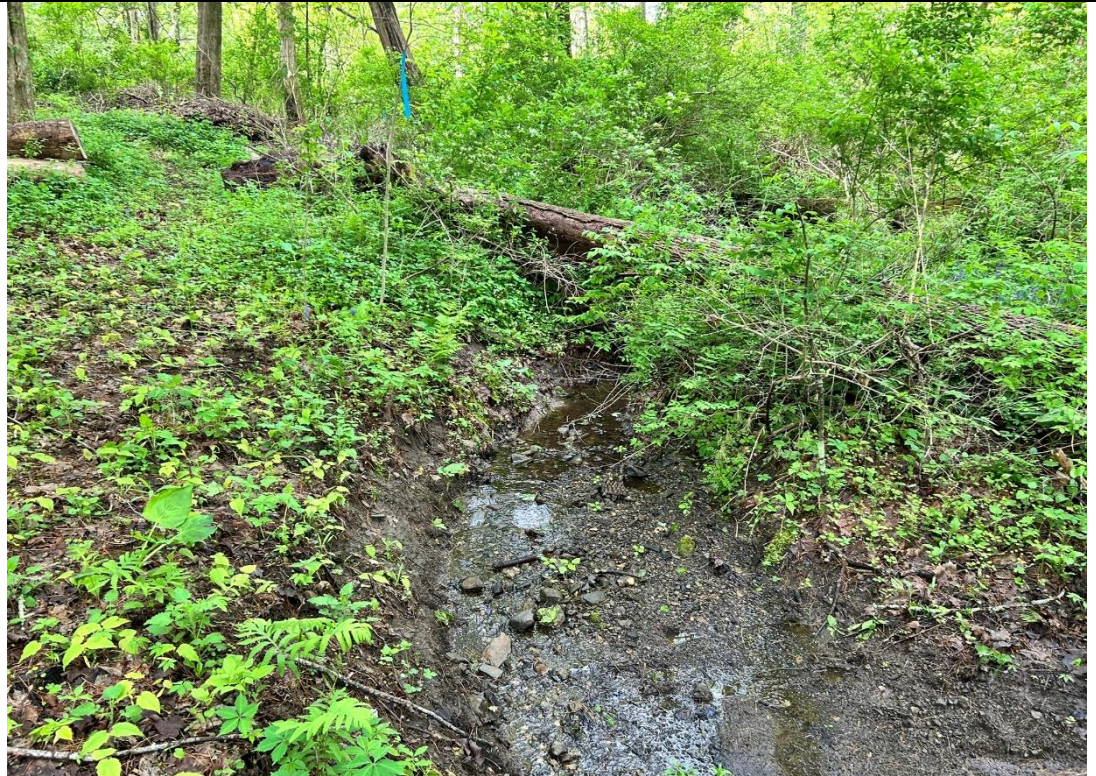
Photo No.  
3

Description:  
Intermittent watercourse  
within Wetland B, facing  
upstream.

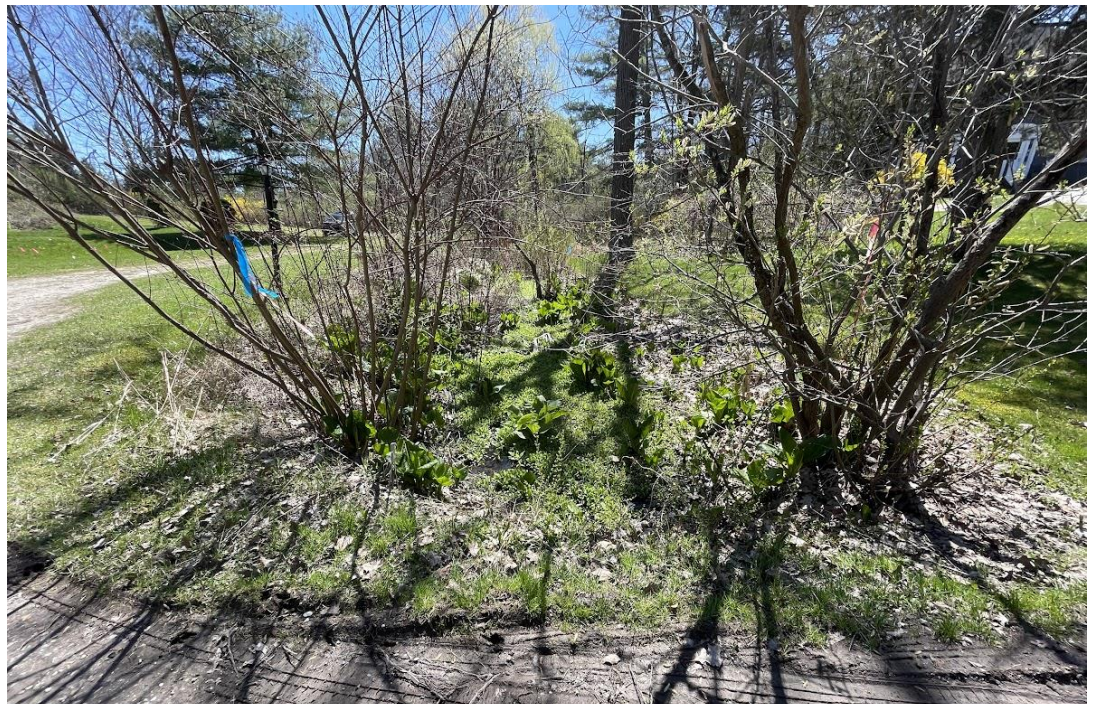
Photo No.  
4

Description:  
Northernmost portion of  
Wetland C facing upstream,  
where its intermittent  
watercourse flows below a  
gravel driveway.

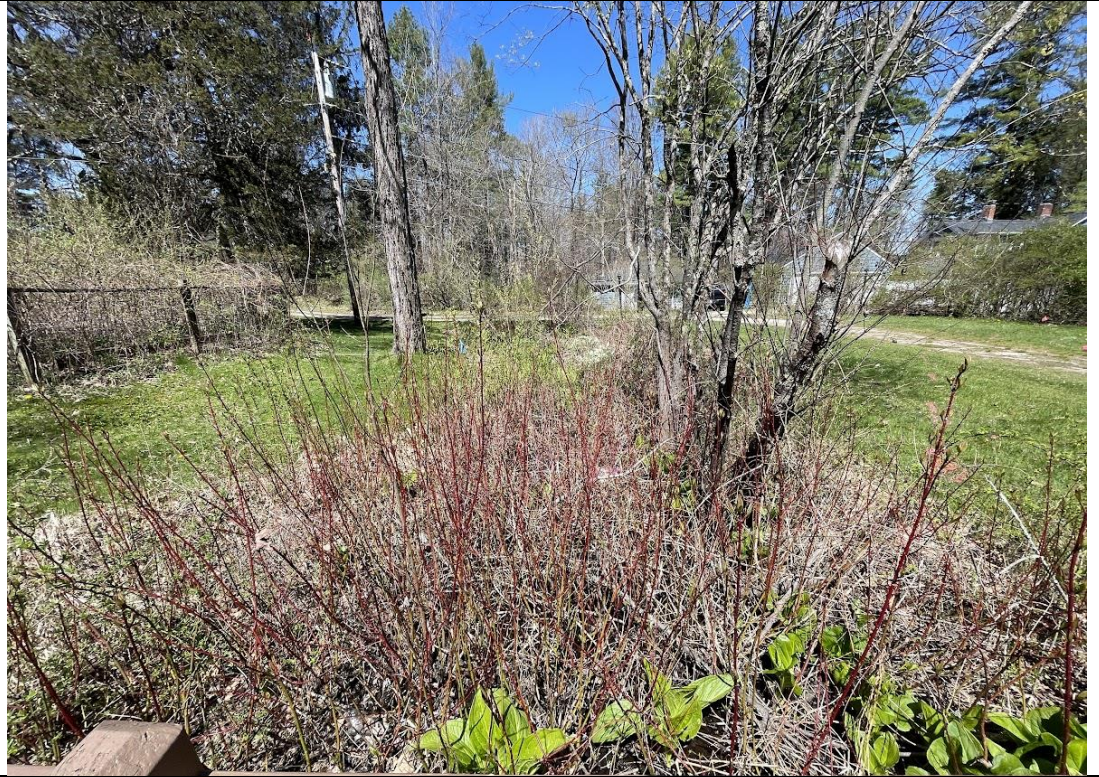
Photo No.  
5

Description:  
Intermittent watercourse  
within Wetland C, facing  
downstream from  
pedestrian bridge.

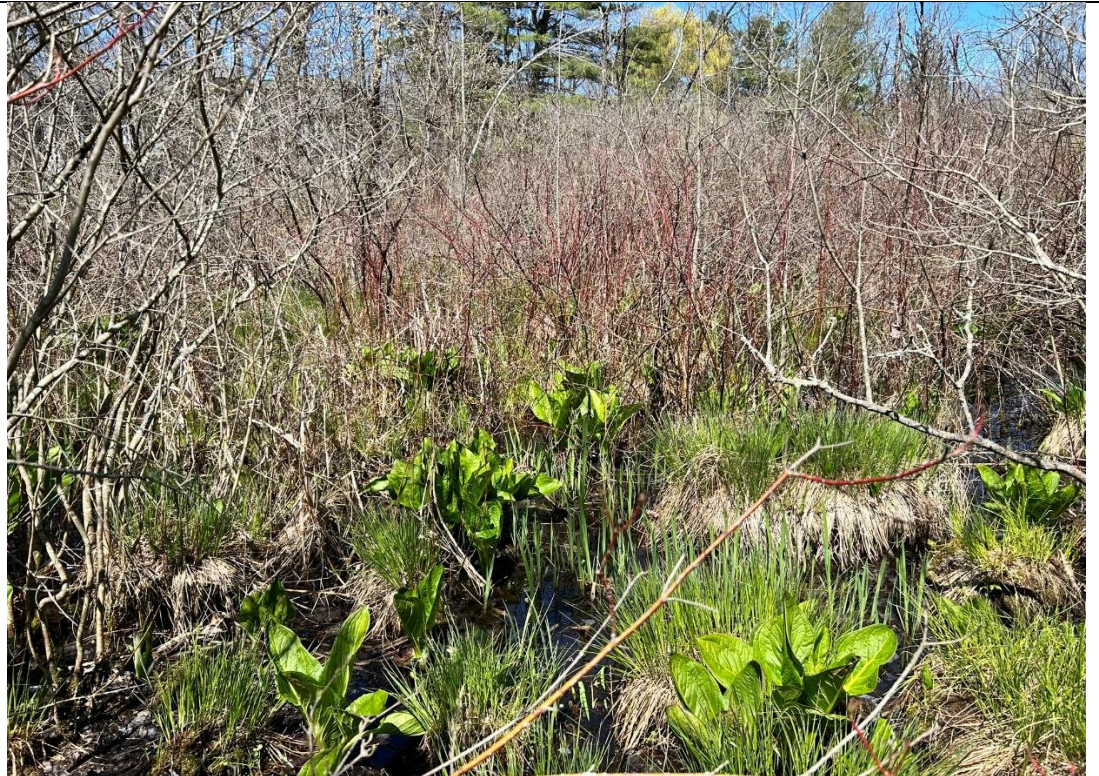
Photo No.  
6

Description:  
Wetland C interior.  
Palustrine Scrub  
Shrub/Emergent Wetland  
habitat.

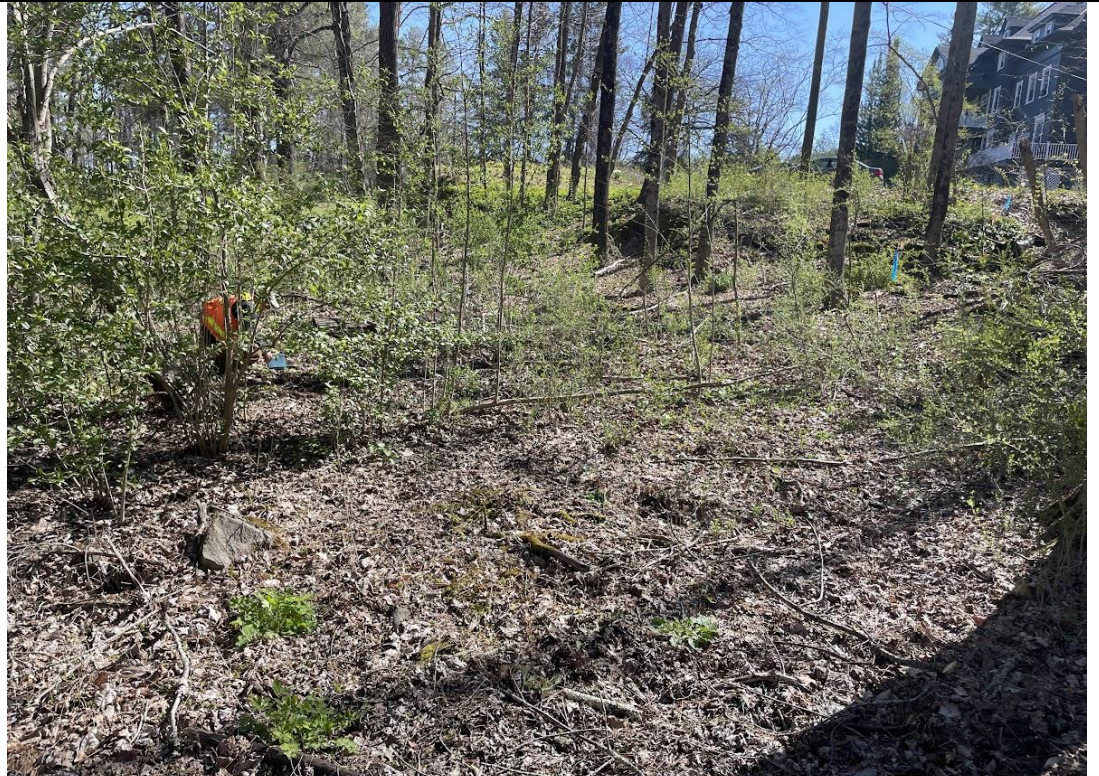
Photo No.  
7

Description:  
Non-wetland area that was included in a previous delineation. SLR found that the area does not display the requisite hydric soils, nor a dominance of hydrophytic vegetation. No evidence of a seasonal high groundwater table was observed in April.

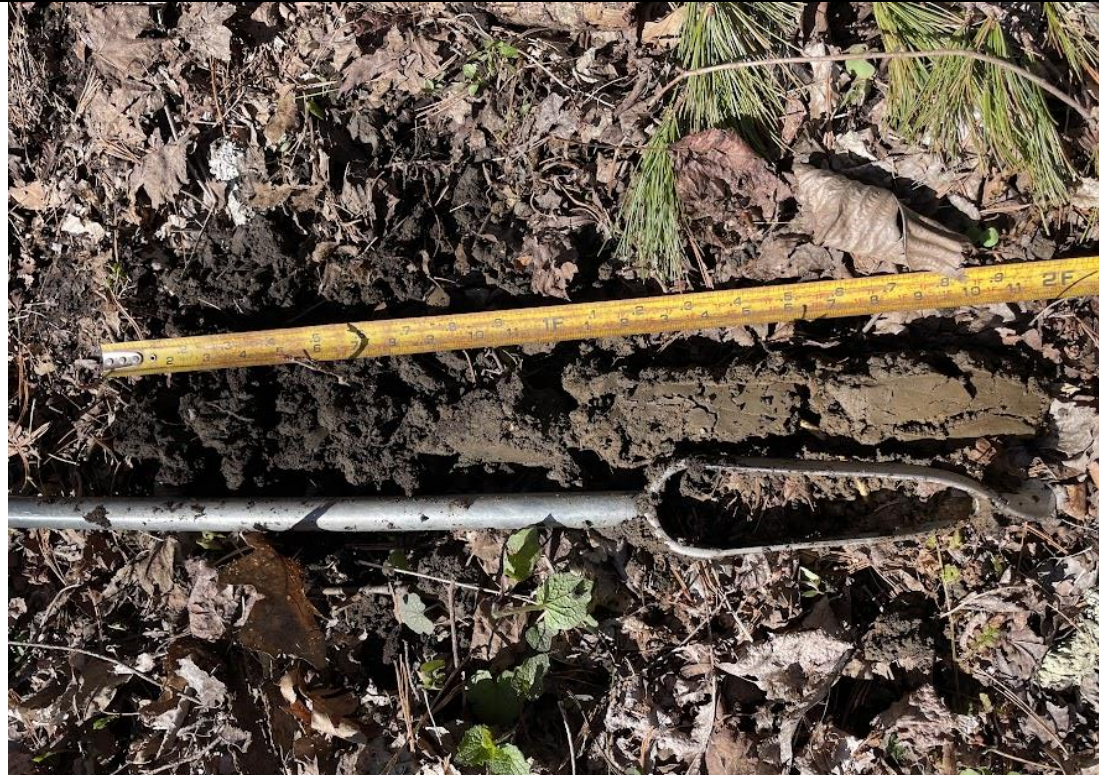
Photo No.  
8

Description:  
Representative soil core (0-24 inches) within the non-wetland area. Soil chroma within the B and C horizons is greater than 2 chroma and does not exhibit strong indications of redox features such as iron depletions and/or concentrations.
